# REPORT ON THE CURRENT WATER SUPPLY CRISIS IN BRONKHORSTSPRUIT AND SURROUNDING AREAS

Quintilla de Vries

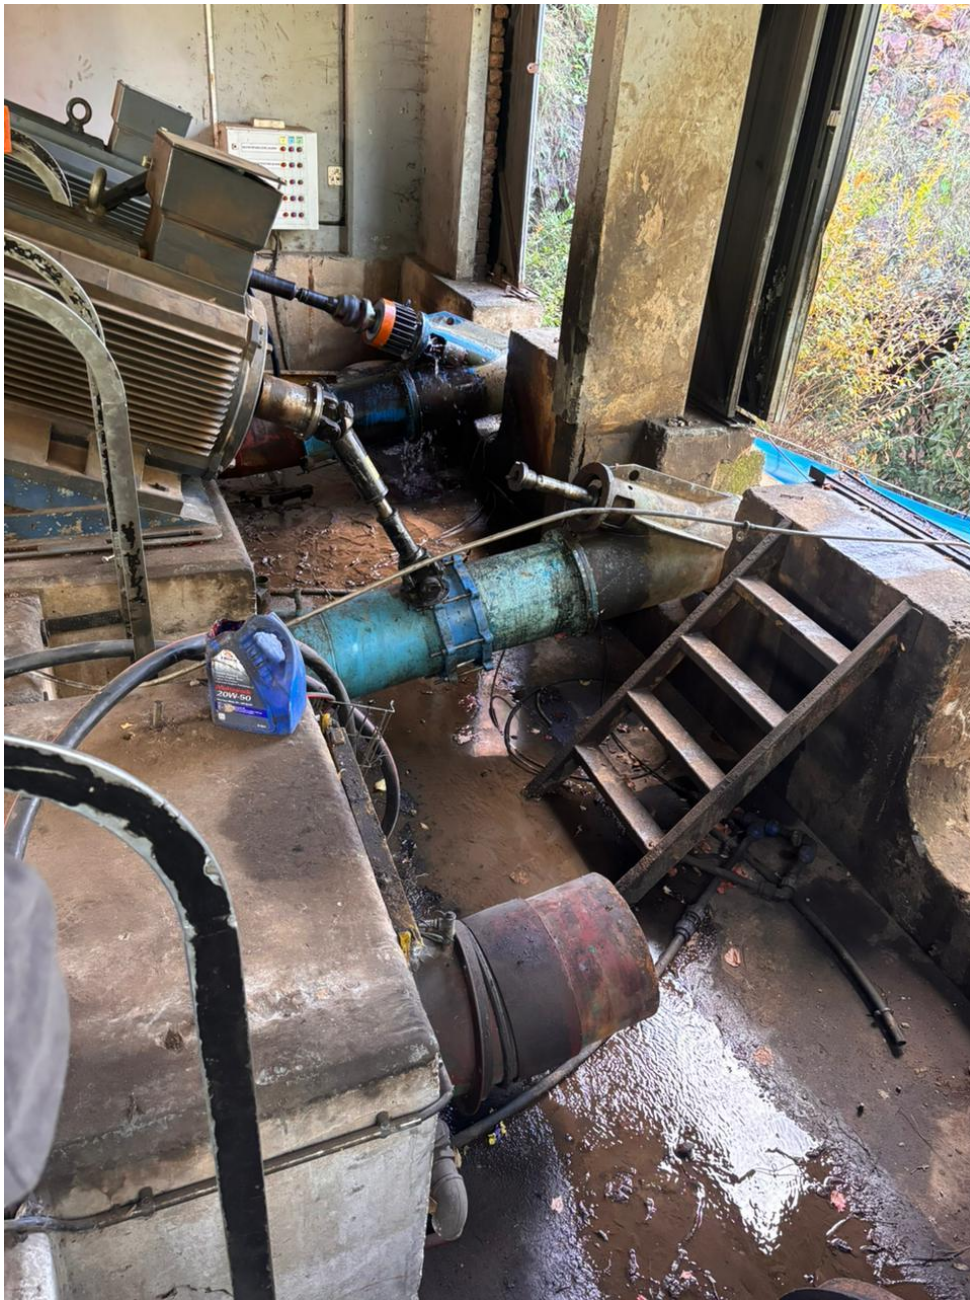
Only one raw-water pump is available and it is extremely old.

- Does not operate at full capacity.
- Represents a single point of failure.
- Supplies the entire treatment plant.

*Raw water pump station: Pump 1 – Aging pump, leaking water. Pump 2 – Disconnected. Pump 3 – No pump and pipes are removed. Picture taken 5 June 2026.*

#### Priority 2: Refurbish Existing Raw Water Pumps

Replace:

- Bearings
- Mechanical seals
- Shaft sleeves
- Impeller
- Motor components

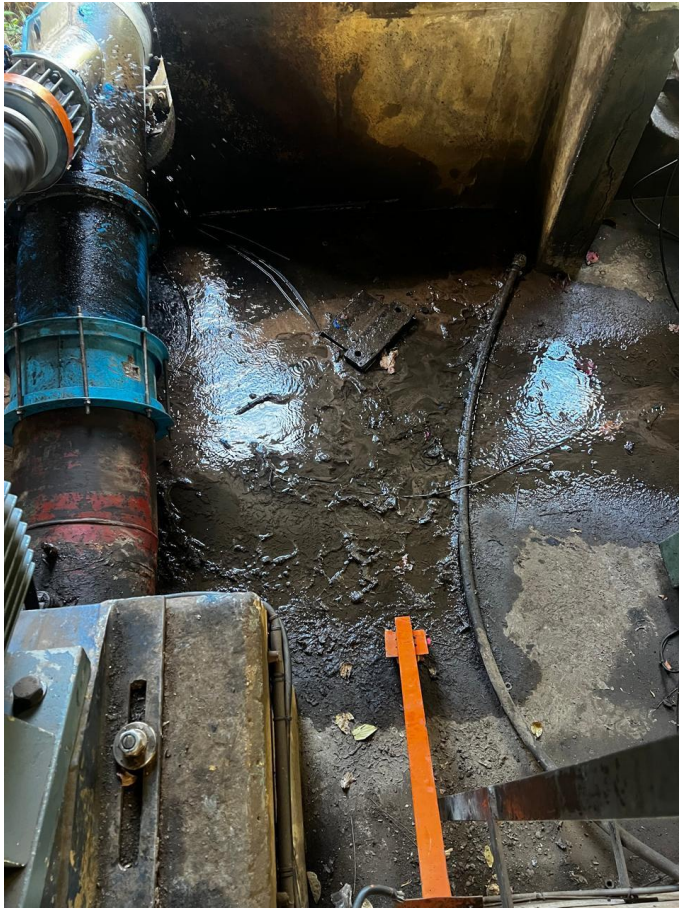
*Water leaking from pump 1 at a rapid speed. Picture taken 5 June 2026.*

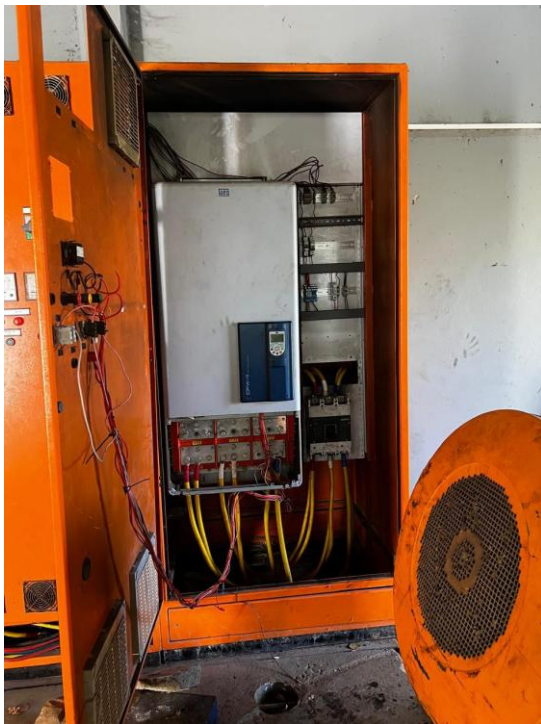
*Pump 1 Electric box condition open*

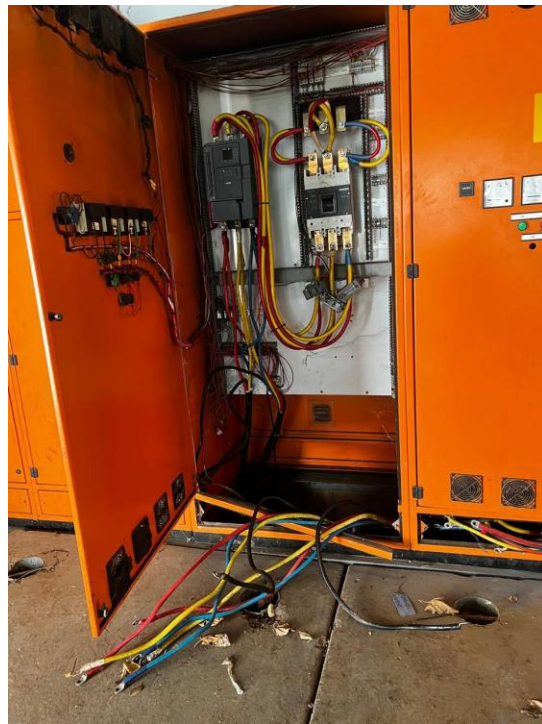
*Pump 2 Electric box condition open*

Pump 2 was refurbished in May 2022, but was wired incorrectly on the 3-phase and broke 2026, according to sources.

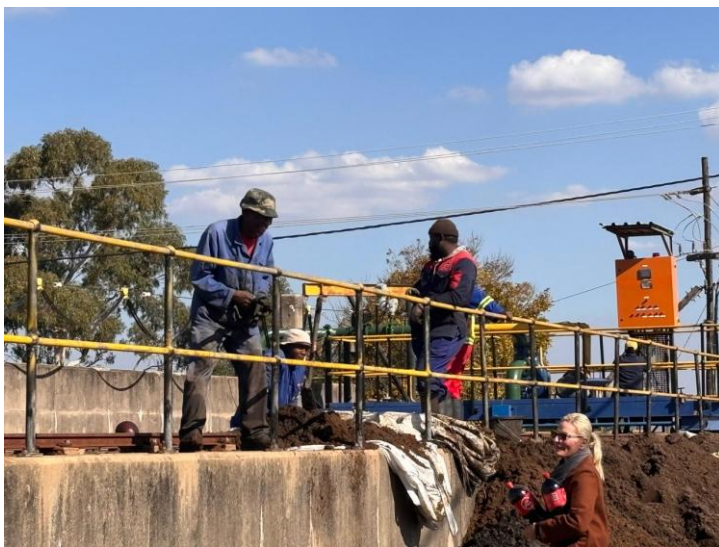
*Phase 2 Filtration system at Bronkhorstspuit Water Treatment Plant change out of sand in the filter:  
Picture taken 15 May 2026.*

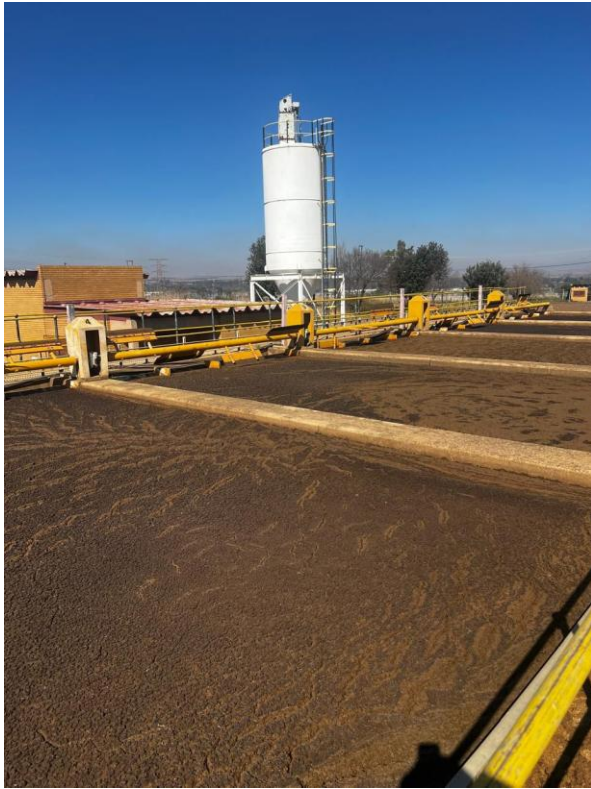
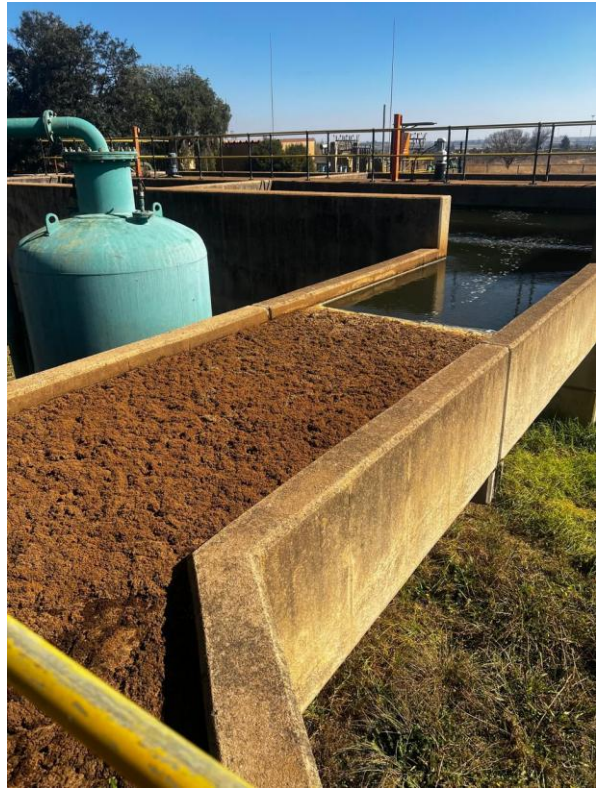
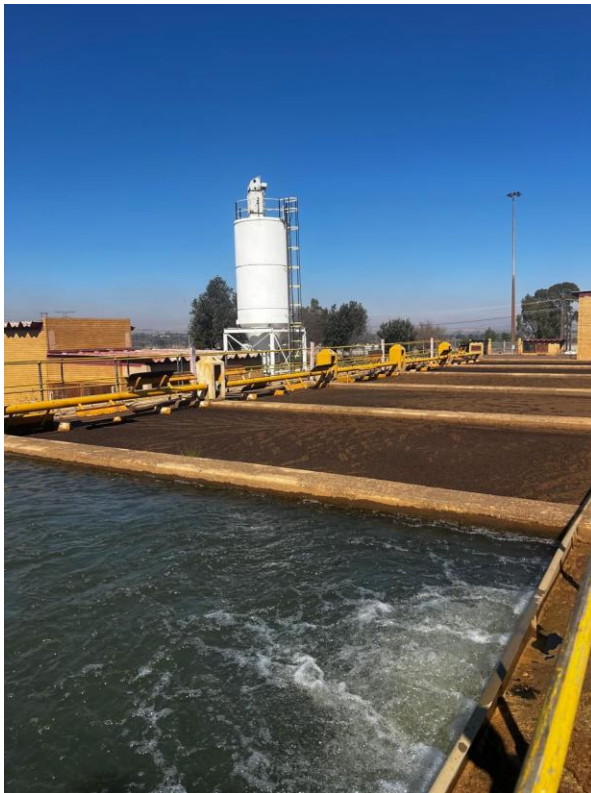
*Phase 1 Filtration system at Bronkhorstspuit Water Treatment Plant: Picture taken 15 June 2026.*

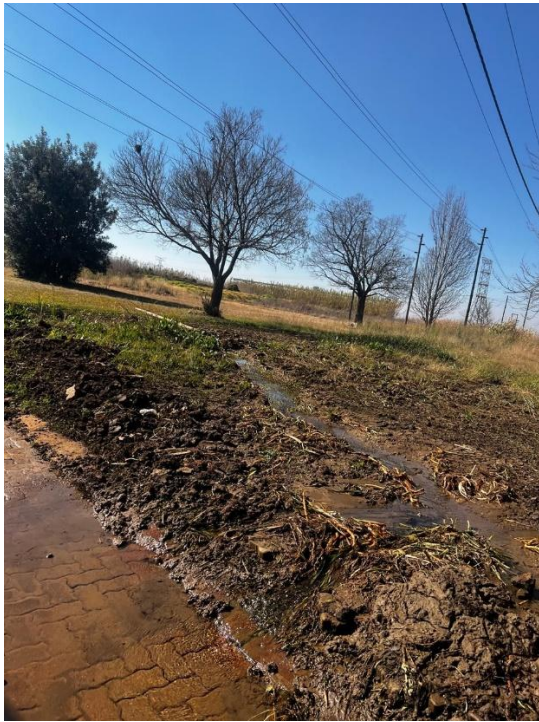
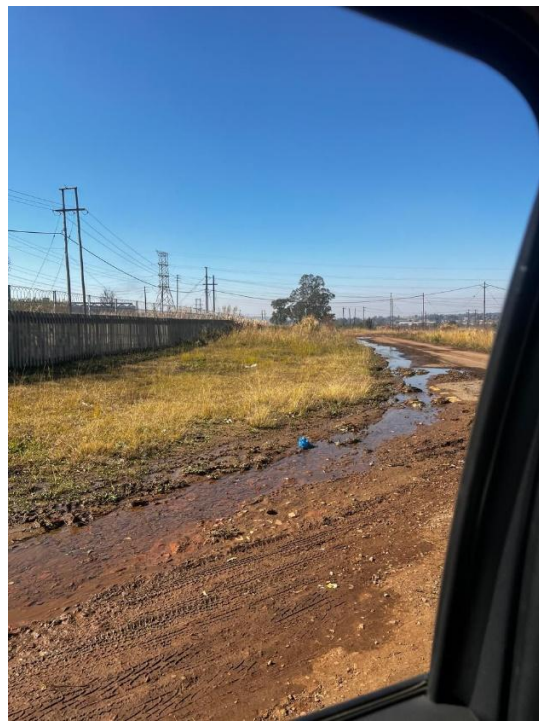
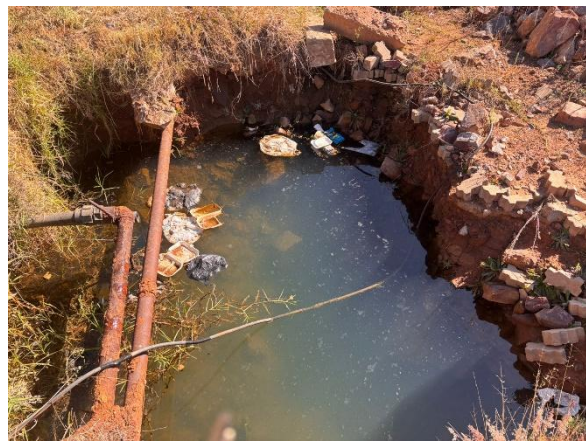
underground water pipeline infrastructure. The existing pipelines are highly susceptible to bursts and are no longer capable of operating reliably under the required system pressure. Restoring the water distribution system to full operational capacity will inevitably increase pressure within the network, resulting in a higher risk of pipeline failures. Consequently, the affected pipeline networks require urgent replacement to ensure the sustainable, reliable, and efficient delivery of water services to the community.

*Water leaks at Bronkhorstspuit Water Treatment Plant. Electrical cable running through the water. Picture taken 15 June 2026.*

### **Leak Detection Programme**
